WL-TR-91-4032
DOT/FAA/CT-91/23
VOL II, Part 2

COMPOSITE FAILURE ANALYSIS HANDBOOK
VOL II - TECHNICAL HANDBOOK
PART 2 - ATLAS OF FRACTOGRAPHS

R.J. Kar
Northrop Corporation
One Northrop Avenue
Hawthorne, California 90250-3277

February 1992

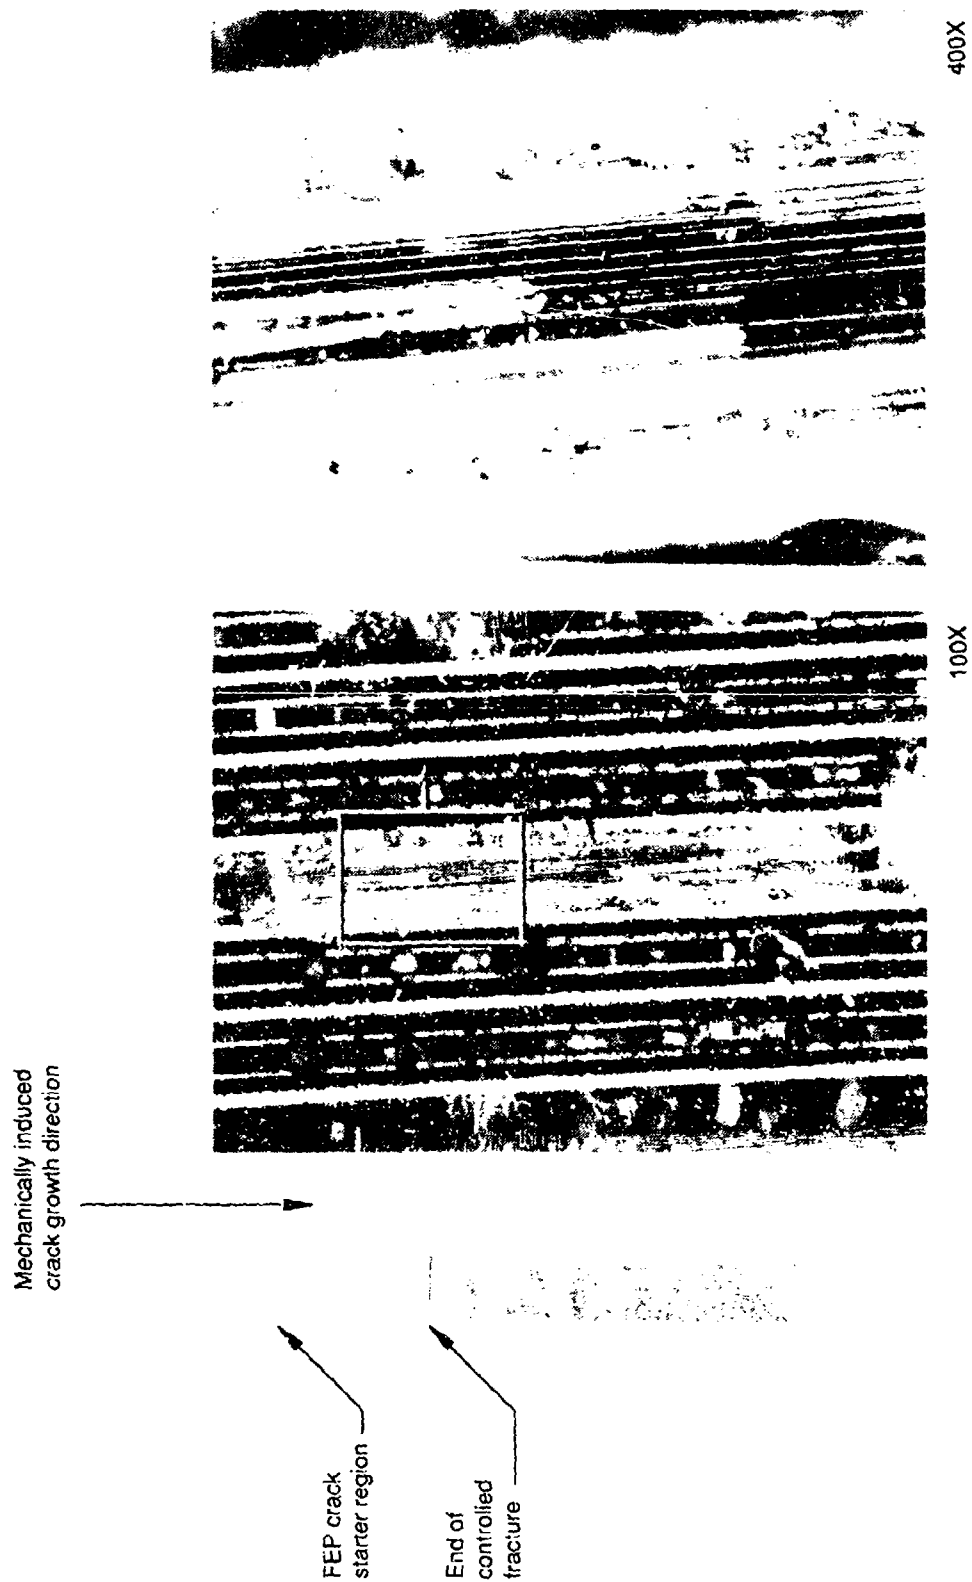
Figure 4-6. Optical Photomicrographs of 270 F/Wet, Interlaminar Mode II Shear, 0/90 Fracture in Boron/Epoxy

Visual examination revealed a fracture surface delaminated at various plies. Hackle formations were observed under the optical microscope (Figure 4-6).

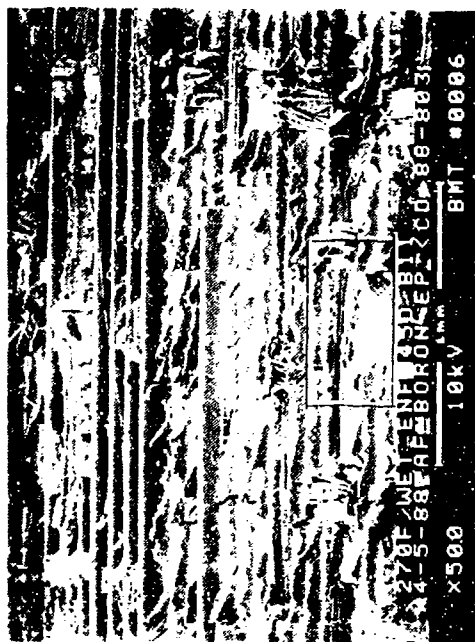
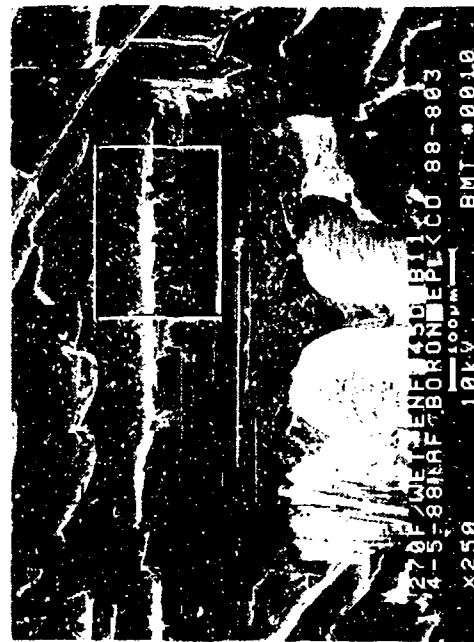
Figure 4-7. SEM Fractographs of 270 F/Wet, Interlaminar Mode II Shear, 0/90 Fracture in Boron/Epoxy

Figure 4-7 illustrates the SEM fractograph of the interlaminar Mode II shear specimen exposed to humidity and tested at 270°F. The fracture surface showed hackles throughout the specimen. Poor fiber/matrix adhesion was observed, which is typical for shear fractures.

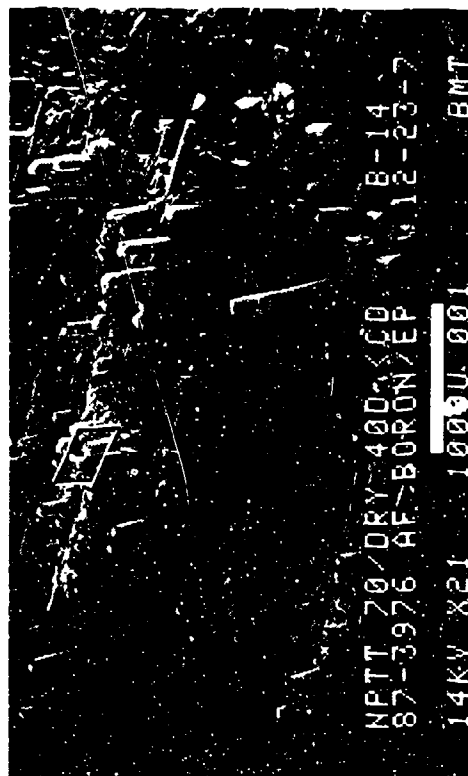
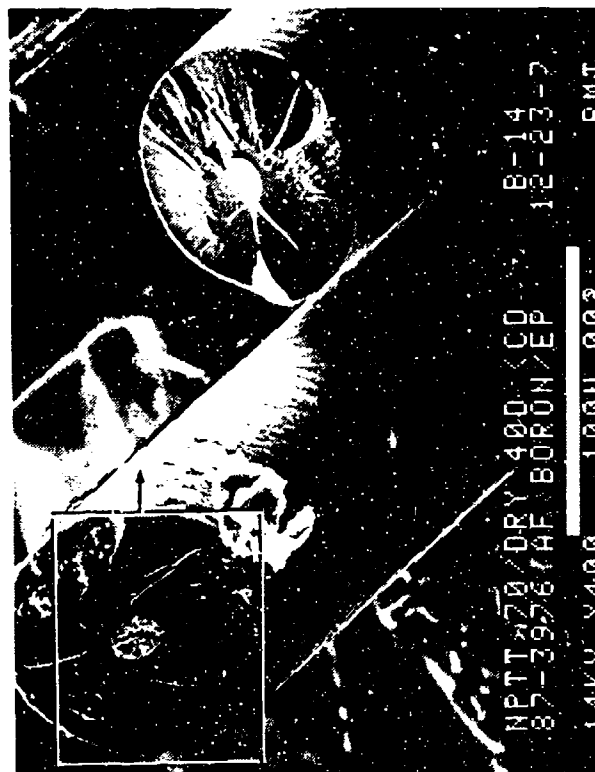
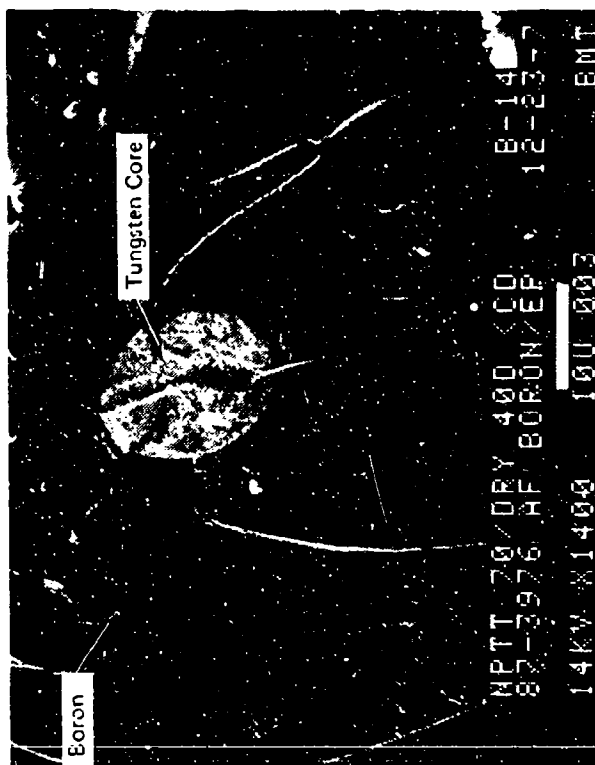
Figure 4-8. SEM Fractographs of Room Temperature/Dry, Translaminar Tension, 0/90 Fracture in Boron/Epoxy

The SEM analysis showed that the adhesion at the interface between the boron fibers and the epoxy matrix was poor at the time of the fracture. This was also evidenced by the fiber pullouts (Figure 4-8).

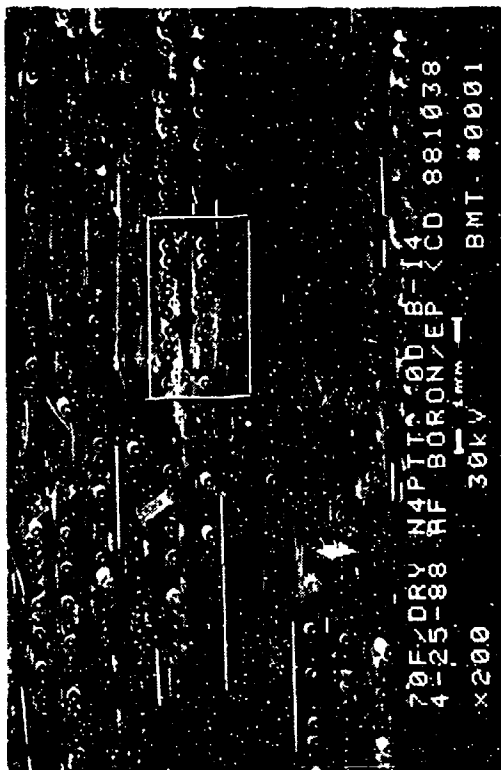
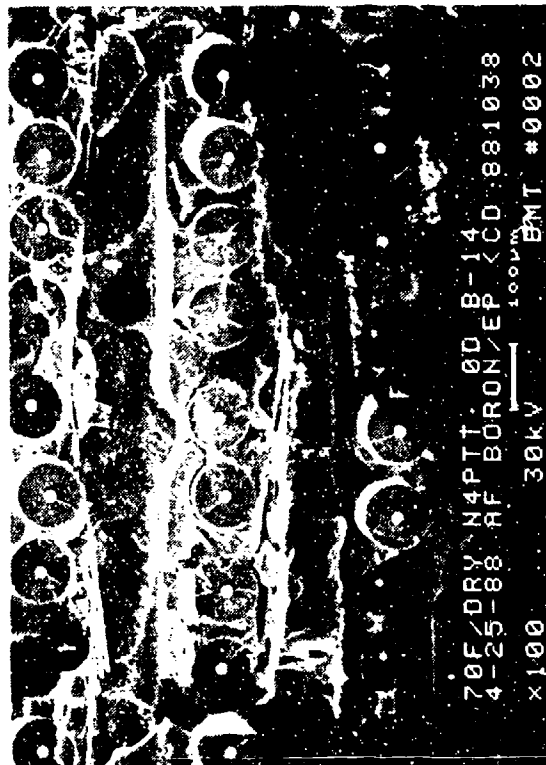
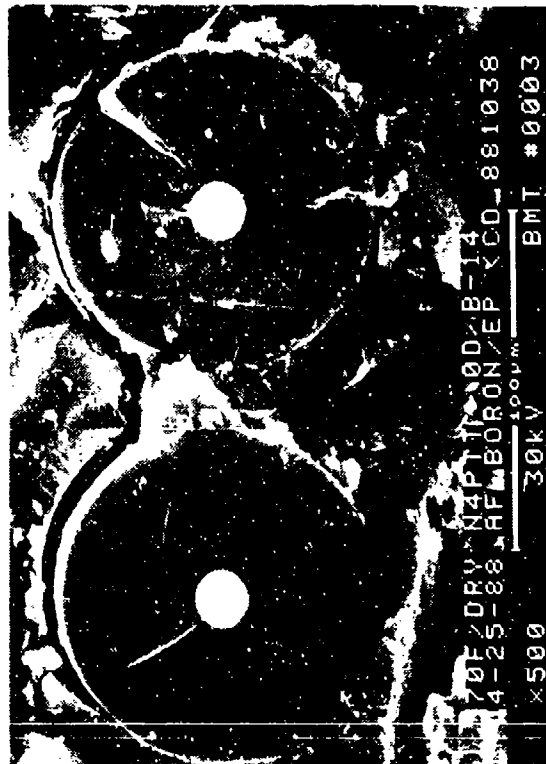
- P fiber pullout
- F fiber end fracture
- M matrix fracture

Figure 4-9. SEM Fractographs of Room Temperature/Dry, Translaminar Tension, 0/90 Fracture in Boron/Epoxy (0 Degree Tilt)

Unlike those in glass and carbon fibers, the radial patterns on the boron fiber ends initiated at the tungsten core/boron interface (Figure 4-9). This phenomenon may be due to the lower interfacial shear strength of the tungsten core/boron interface in comparison with the boron fiber/epoxy interface. The fracture features radiating from the center of the boron-tungsten fiber could not be used to determine the crack surface and propagate from one fiber to another, and the average of the individual crack directions indicated the overall crack direction.

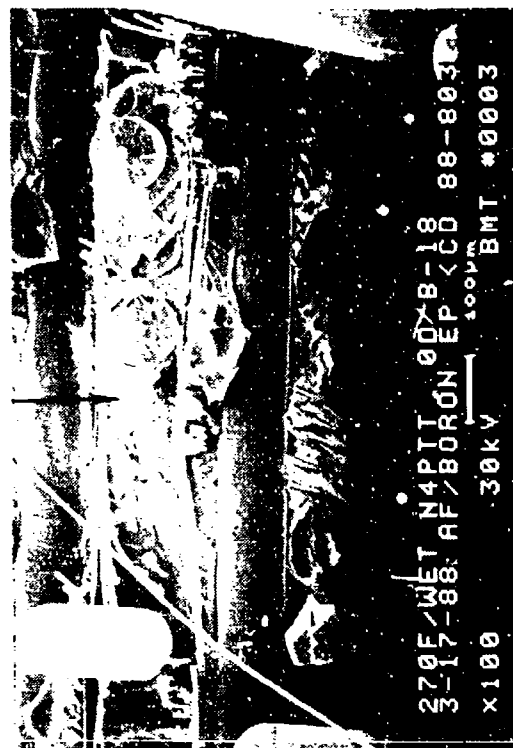
Interlaminar resin fracture
(i.e. rivermarks)

Figure 4-10. SEM Fractographs of 270 F/Wet, Translaminar Tension, 0/90 Fracture in Boron/Epoxy (45 and 0 Degree Tilts)

Visual examination revealed a fracture surface with numerous protruding fibers. Under the wide-field macroscope, it was evident that the fracture was fiber-dominated. The fracture surface exhibited many holes in the matrix, indicative of extensive fiber pullout (poor fiber/matrix adhesion). Additionally, the fibers pulled away from the matrix were much longer than those in the RT/dry specimen. This also indicated poor fiber/matrix adhesion (Figure 4-10).

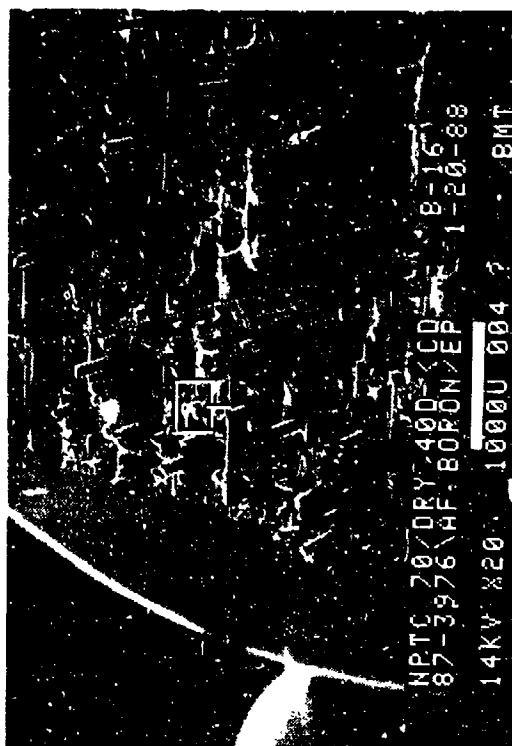
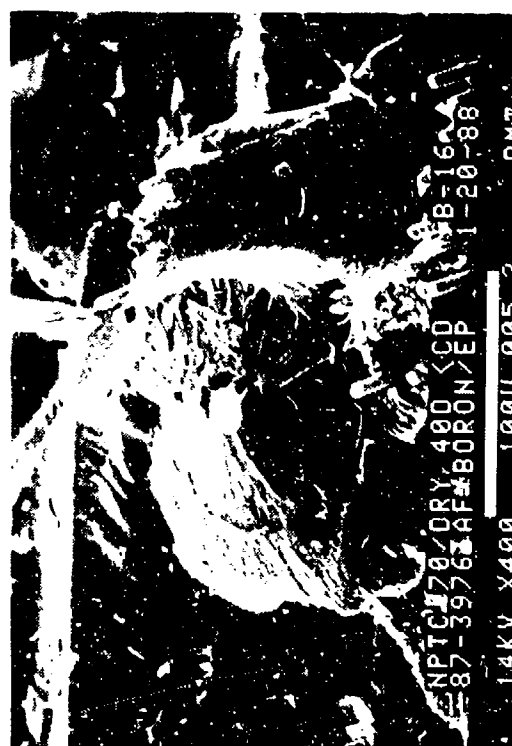
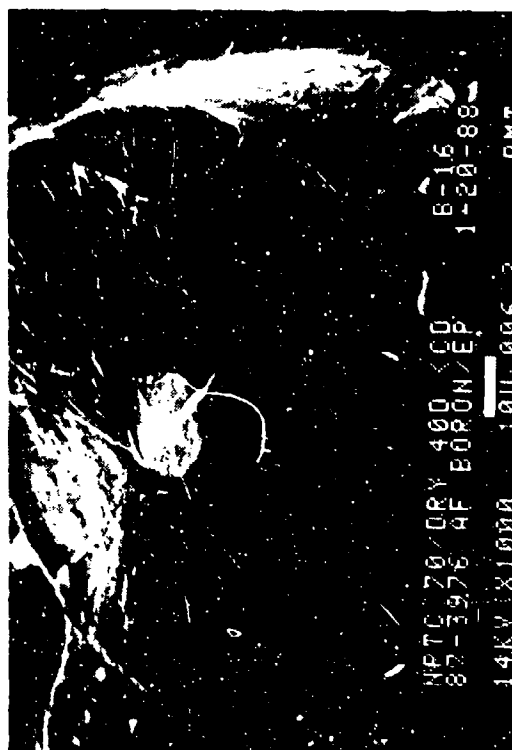
Figure 4-11. SEM Fractographs of Room Temperature/Dry, Translaminar Compression, n/90 Fracture in Boron/Epoxy (40 Degree Tilt)

Visual observation revealed numerous protruded boron-tungsten filaments. SEM analysis shown in Figures 4-11 and 4-12 confirmed the visual result. Unlike the glass and carbon fibers, the boron-tungsten fibers exhibited similar fracture features in both tension and compression specimens. This may be due to the higher ductility of the boron-tungsten fibers in comparison with the glass and carbon fibers. This eliminates the microbuckling effects (from compression) typically exhibited in fibers with higher stiffness. The neutral axes observed on the glass and carbon fiber ends were not present on the boron-tungsten translaminar compression specimen tested under RT/dry condition.

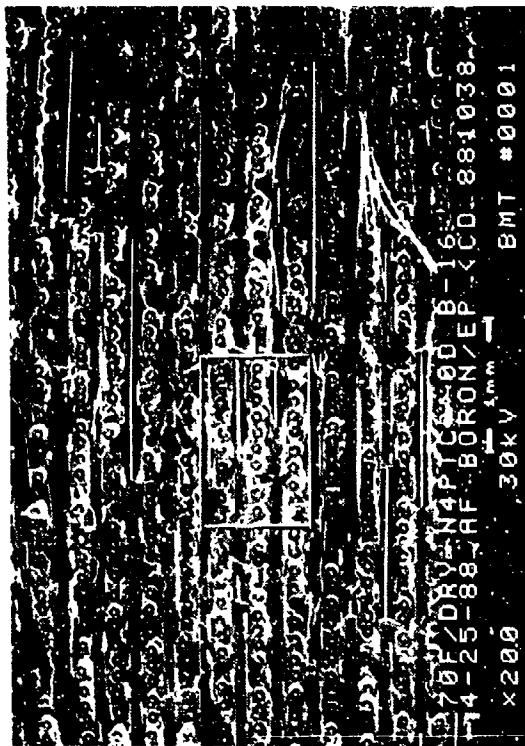
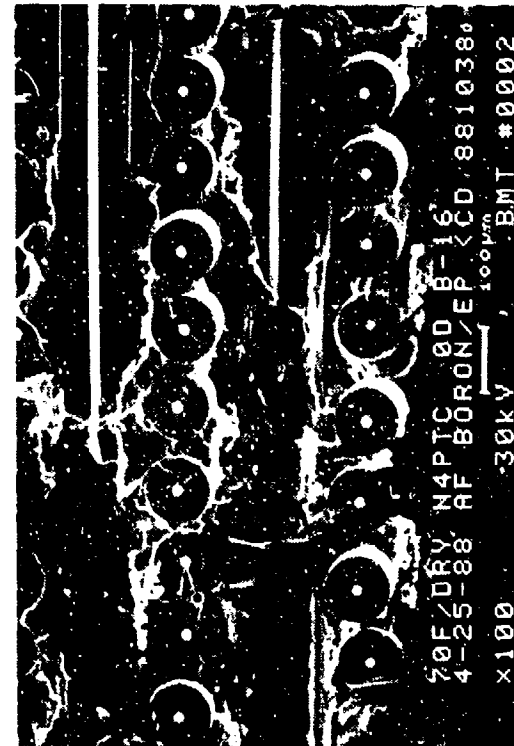
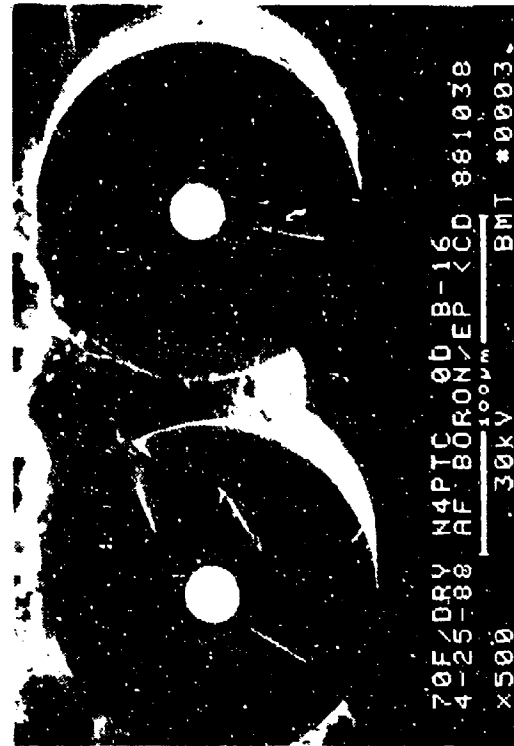
Figure 4-12. SEM Fractographs of Room Temperature/Dry, Translaminar Compression, 0/9C Fracture in Boron/Epoxy (0 Degree Tilt)

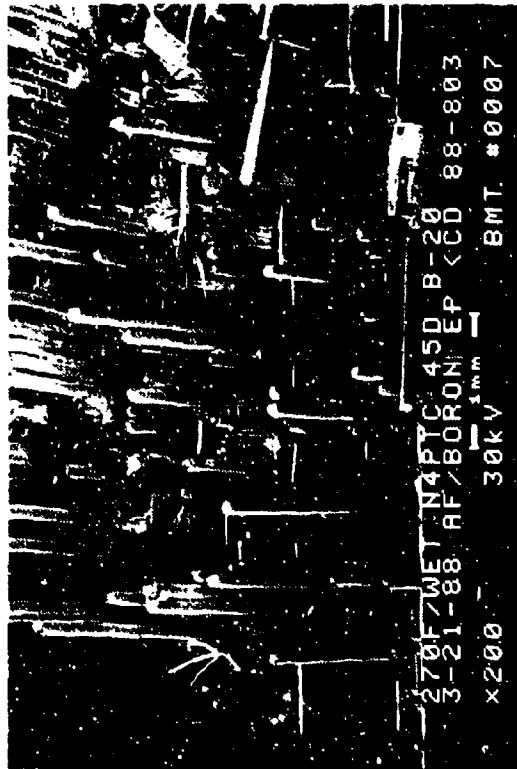
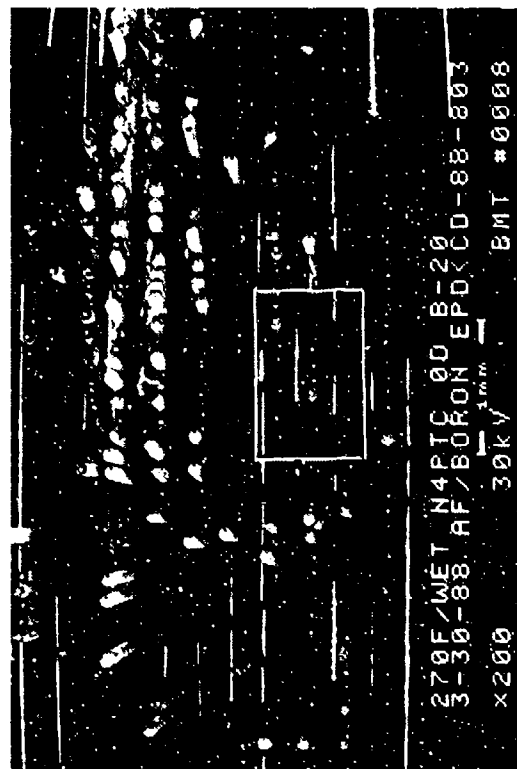
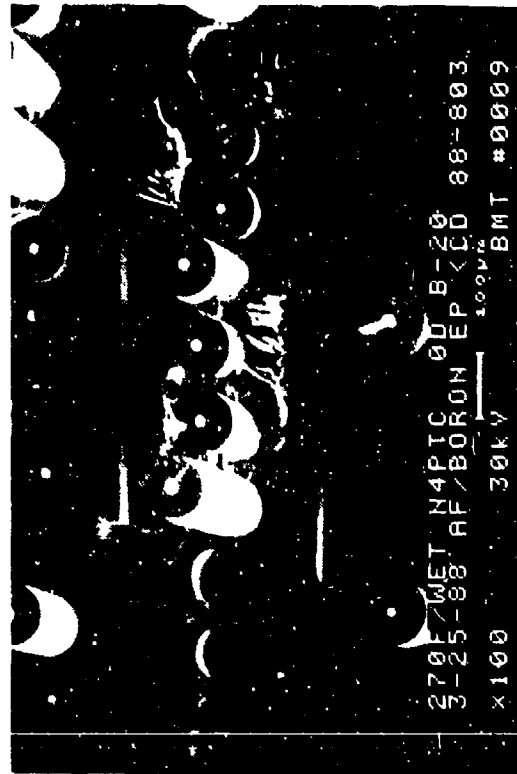
Figure 4-13. SEM Fractographs of 270 FWet, Translaminar Compression, 0/90 Fracture in Boron/Epoxy

Visual examination revealed a fracture surface with numerous protruding fibers, similar to the fracture surface of the tension specimen. The ends of the boron filaments exhibited radial patterns similar to those of the translaminar compression RT/dry specimen (Figure 4-13). Boron fiber pullouts exhibited little residual resin on the fiber due to weak fiber/matrix adhesion; also, the boron fiber surface was not as smooth as is typical of carbon fiber (Figure 4-14). This is due to the chemical deposition process of boron onto the tungsten core. The neutral axes typically observed on glass and carbon fiber ends, a result of microbuckling, were not present on the boron-tungsten translaminar compression specimen tested under 270°F/wet conditions.

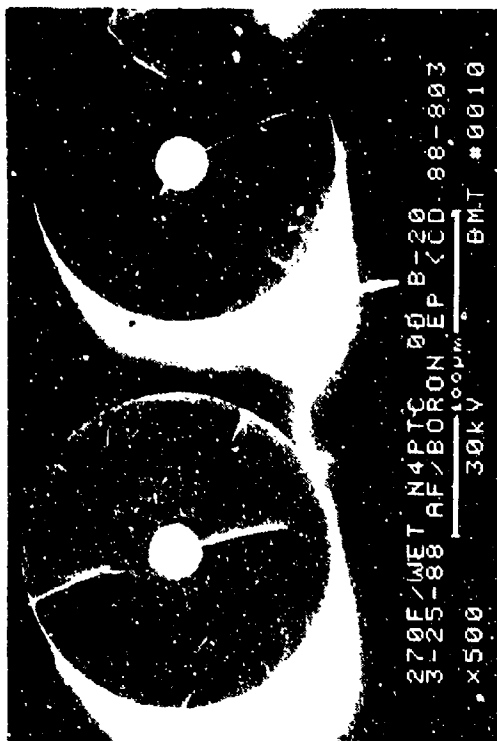
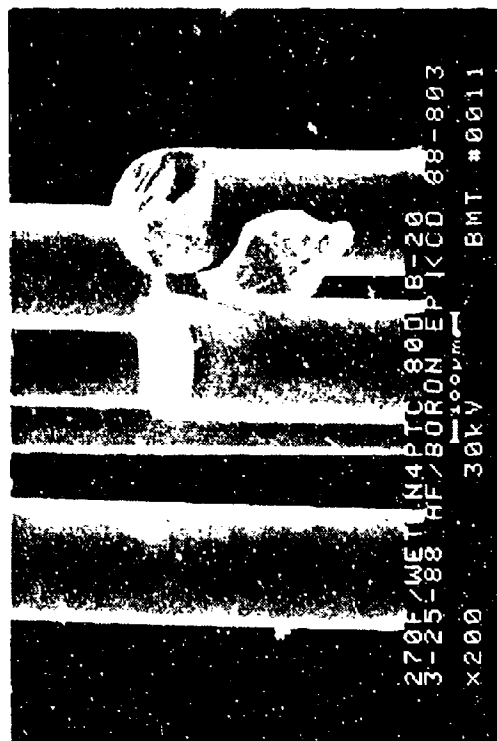
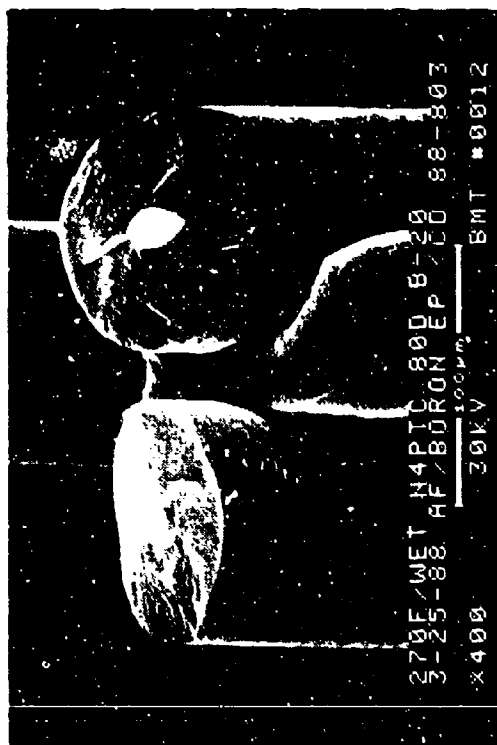
Figure 4-14. SEM Fractographs of 270 F/Wet, Translaminar Compression, 0/90 Fracture in Boron/Epoxy (High Magnification)

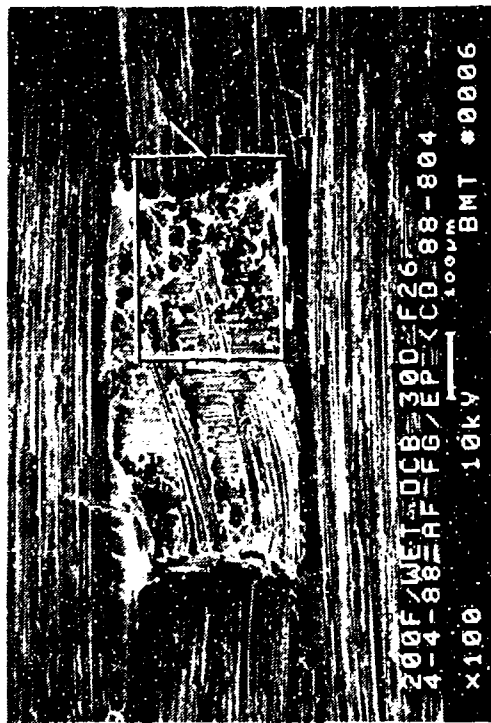
Figure 5-2. SEM Fractographs of 200 F/Wet, Interlaminar Mode I Tension, 0/90 Fracture in Fiberglass/Epoxy

Figure 5-2 shows the SEM fractographs of the interlaminar Mode I tension, 200°F/wet specimen. Fiber/matrix adhesion was poor as evidenced by the smoothness of the fiber surface. Unlike the RT/dry specimen, this specimen, did not exhibit well-defined river marks indicating the crack direction. Instead, the surface showed taffy-pull hackles commonly seen in ductile resin matrices such as thermoplastics.

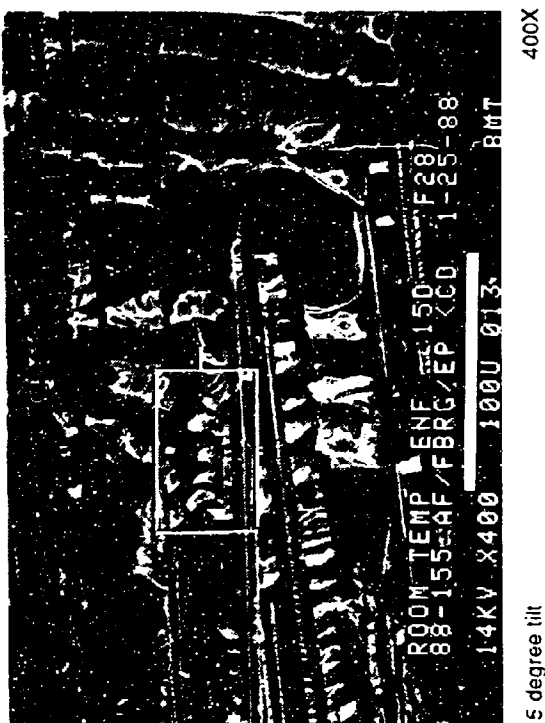
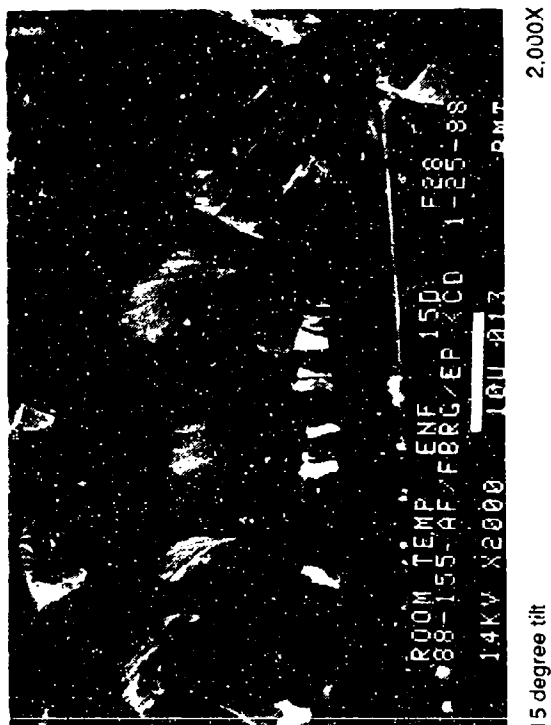
Legend:
F fiber/matrix separation
H hackle

Figure 5-3. SEM Fractographs of Room Temperature/Dry, Interlaminar Mode II Shear, 0/90 Fracture in Fiberglass/Epoxy

SEM analysis (Figure 5-3) revealed a rough fracture surface consisting of large numbers of hackles, which appear similar to the platelets seen in Mode II shear fractures of carbon fiber reinforced epoxies. There was poor adhesion of the fiber/matrix interface at some locations, which was due to the low inherent interfacial shear strength.

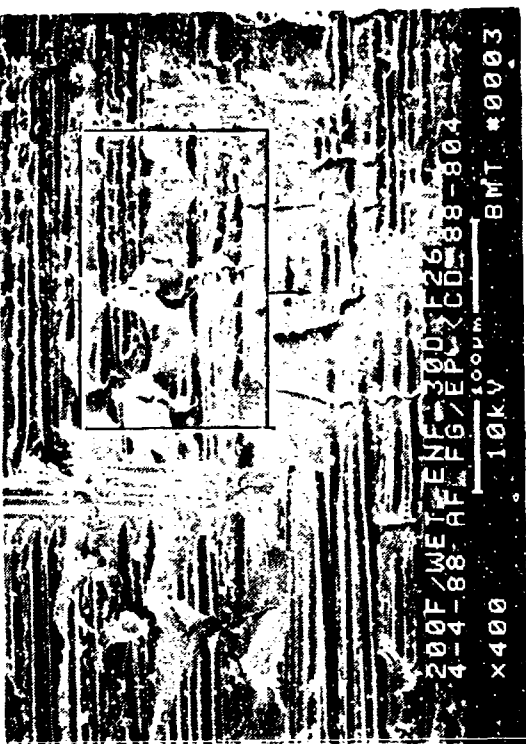
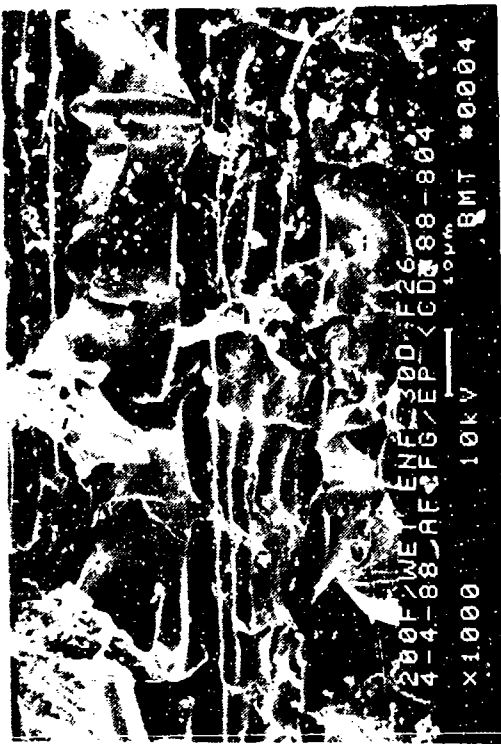
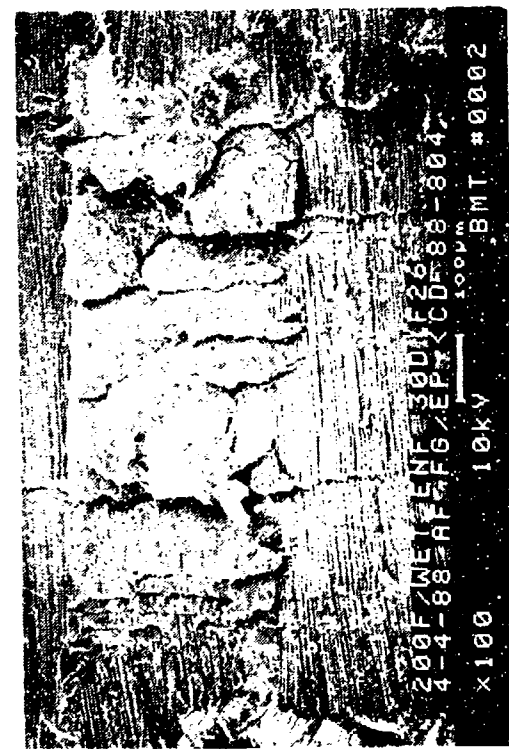
(a) 20X 30 degree tilt

(b) 400X 30 degree tilt

(c) 100X 30 degree tilt

(d) 1,000X 30 degree tilt

Figure 5-4. SEM Fractographs of 200 F/Wet, Interlaminar Mode II Shear, 0:90 Fracture in Fiberglass/Epoxy

Figure 5-4 shows the SEM fractograph of the fracture surface which appeared rough and showed hackles as observed in the RT/dry specimen. These hackles were much larger, but fewer in number than those seen in the RT specimens.

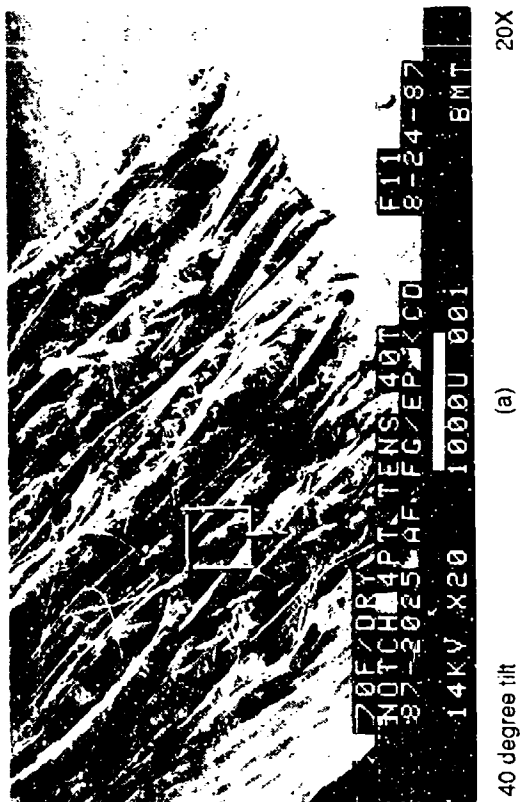
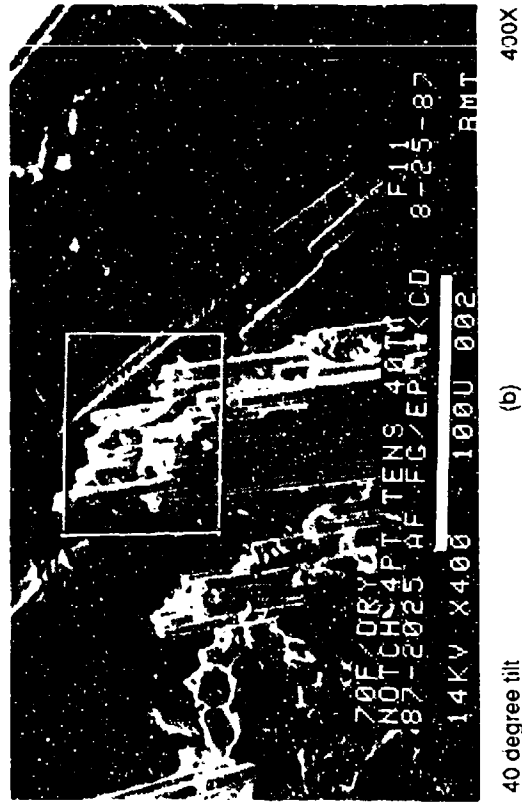
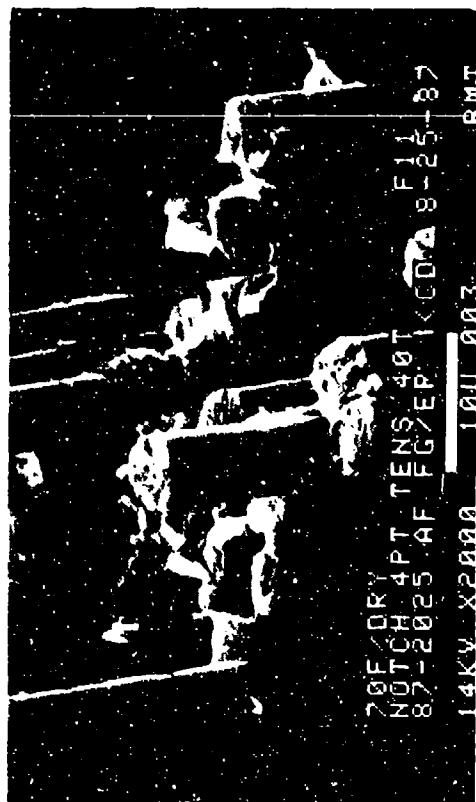
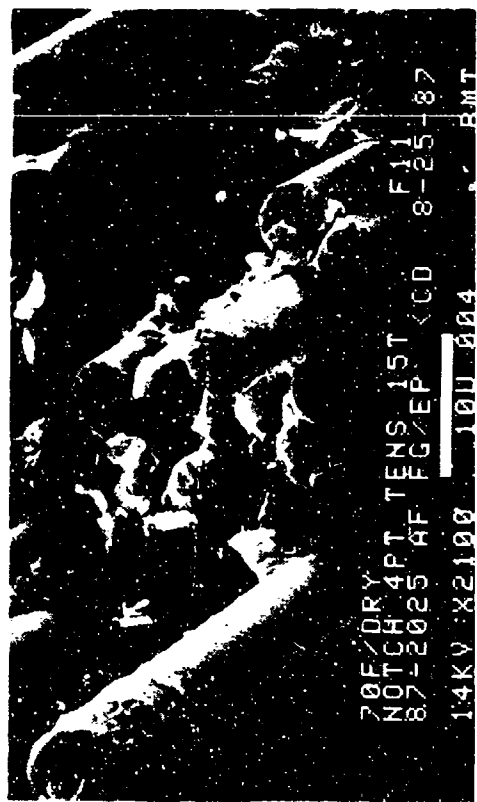
Note: Higher magnifications of the boxed regions are shown in (c) and (d)

Figure 5-5. SEM Fractographs of 70 F/Dry, Translaminar Tension, 0/90 Fracture in Fiberglass/Epoxy

40 degree tilt (c) 2,000X

15 degree tilt (d) 2,000X

Figure 5-5. SEM Fractographs of 70 F/Dry, Translaminar Tension, 0/90 Fracture in Fiberglass/Epoxy (Concluded)

Visual and optical observation revealed a rough topography with protruding fibers of different lengths and directions (Figure 5-5). The surface of the fiber/matrix interface was smooth due to the fibers being pulled away from the matrix. There was evidence of fiber dominated fracture in the large percentage of fiber pullouts. Similar to the carbon fibers, the radial patterns were observed on the glass fiber ends and can be used to determine crack growth direction.

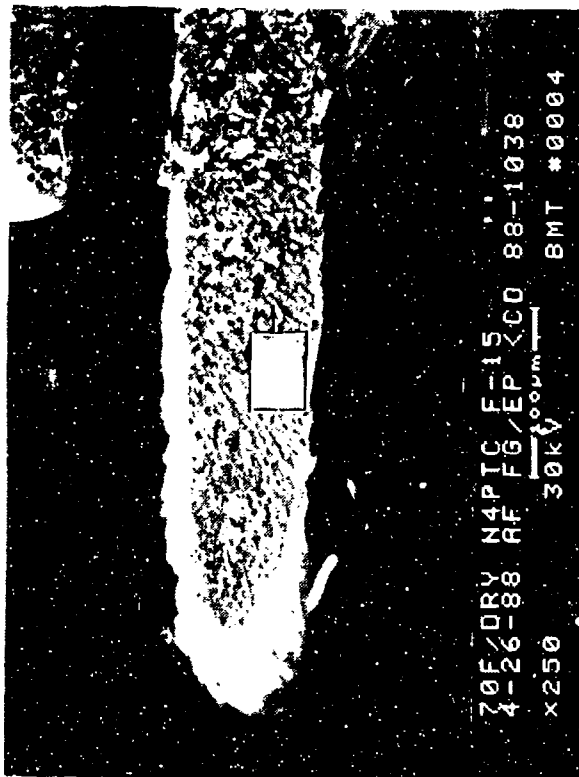
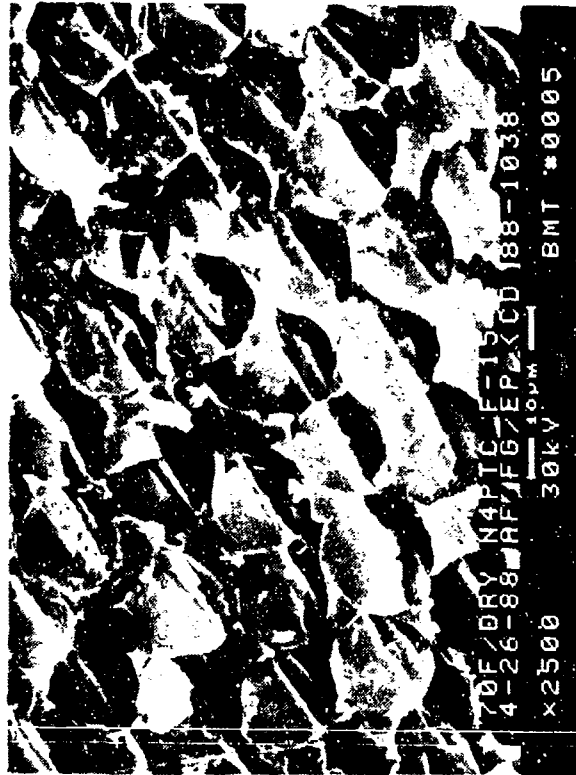
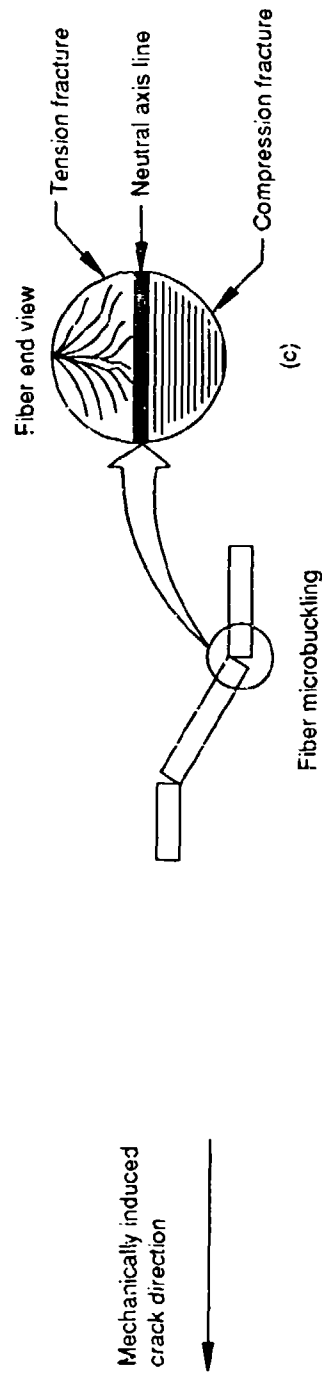
0 degree tilt

Figure 5-6. SEM Fractographs and Diagram of 70 F/Dry, Translaminar Compression, 0/90 Fracture in Fiberglass/Epoxy (0 Degree Tilt)

Visual and optical observations revealed a surface with uniform protruding fibers. The fiber/matrix interface showed good adhesion. Figures 5-6 and 5-7 show the SEM fractographs. A neutral axis line dividing the tension and compression regions on the fiber ends was observed.

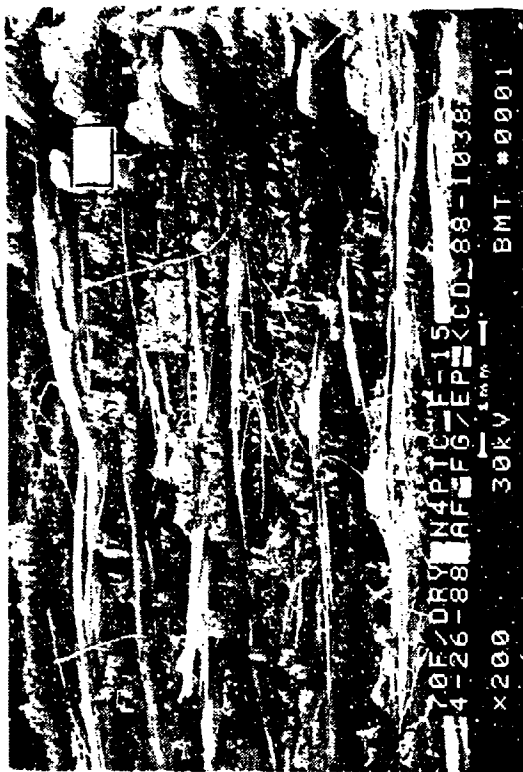
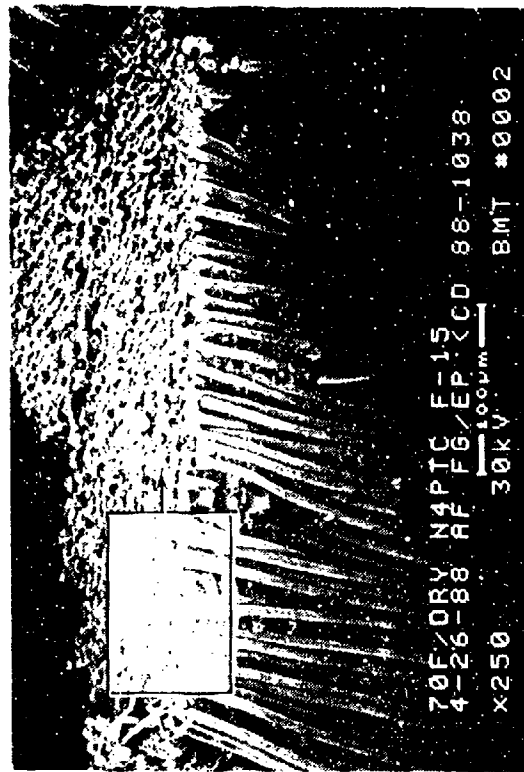
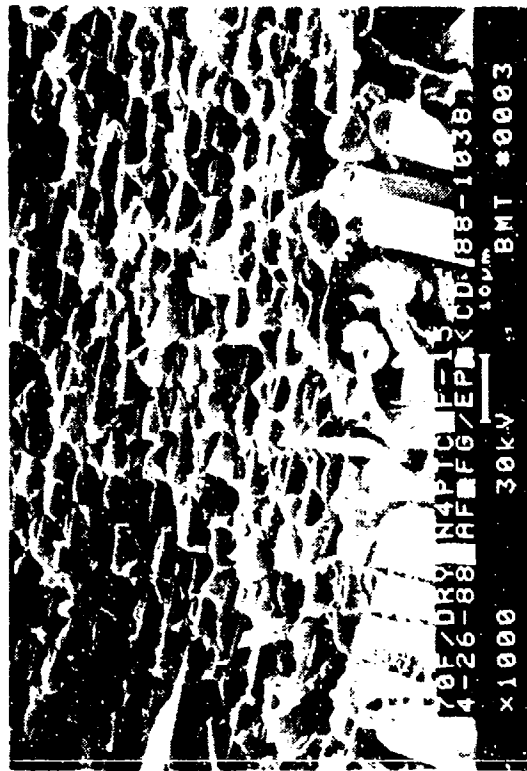
45 degree tilt (a) 20X

45 degree tilt (b) 250X

45 degree tilt (c) 1,000X

Figure 5-7. SEM Fractographs of 70 F/Dry, Translaminar Compression, 0/90 Fracture in Fiberglass/Epoxy (45 Degree Tilt)

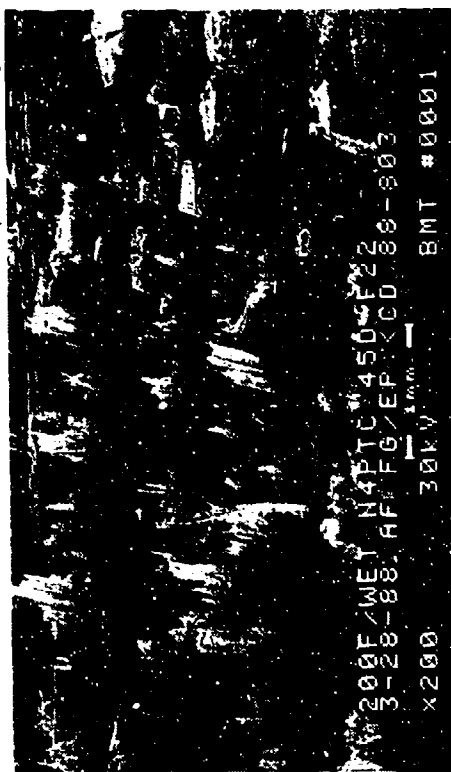
Region representing the
compression damage

45 degree tilt (a) 20X

45 degree tilt (b) 250X

(c) 400X

Figure 5-8. SEM Fractographs of 200 F/Wet, Translaminar Compression, 0/90 Fracture in Fiberglass/Epoxy (45 Degree Tilt)

Optical observation of the 200°F/wet specimen revealed a fracture surface like that typically seen in RT/dry translaminar compression specimens. The compression damage occurred in the region just outside of the notch. The typical fracture of a translaminar compression specimen exhibited a flat surface with "chop" marks on the fiber ends (Figure 5-8). Compressively fractured fiber ends show two distinct regions separated by a neutral axis line. This line does not represent any kind of crack direction (Figure 5-9).

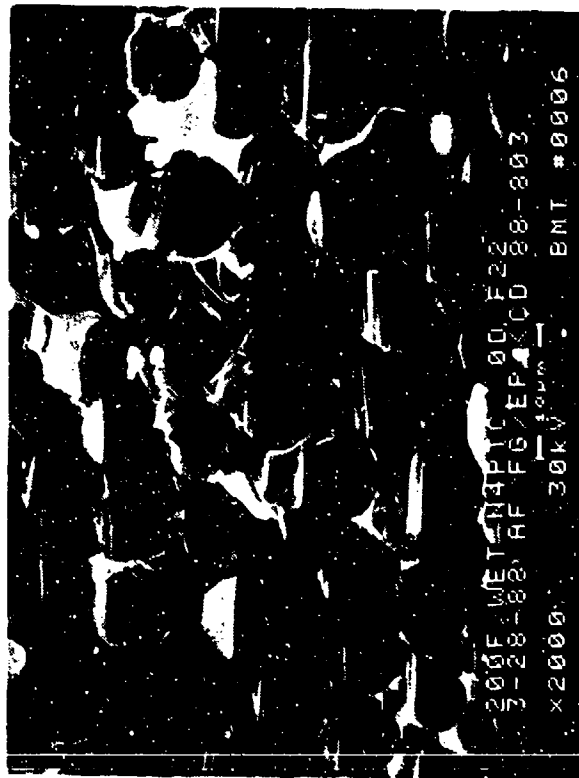
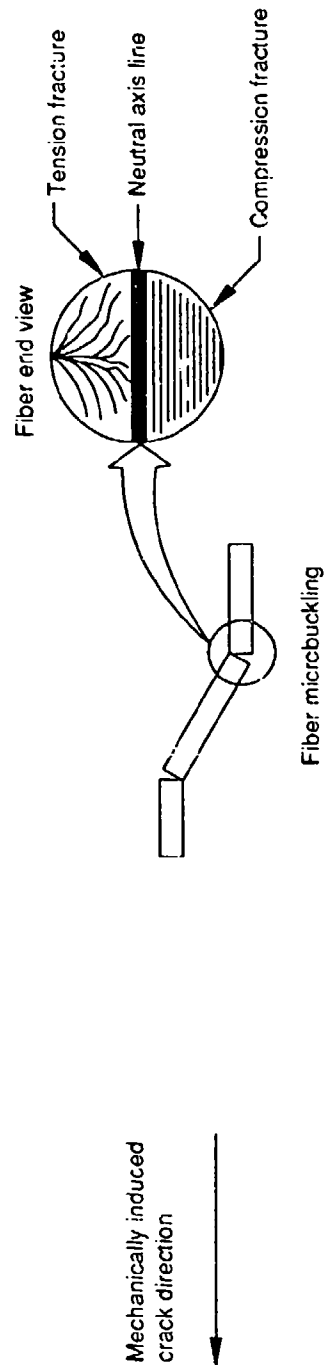
Figure 5-9. SEM Fractographs of 200 F/Wet, Translaminar Compression, 0/90 Fracture in Fiberglass/Epoxy (Higher Magnification)

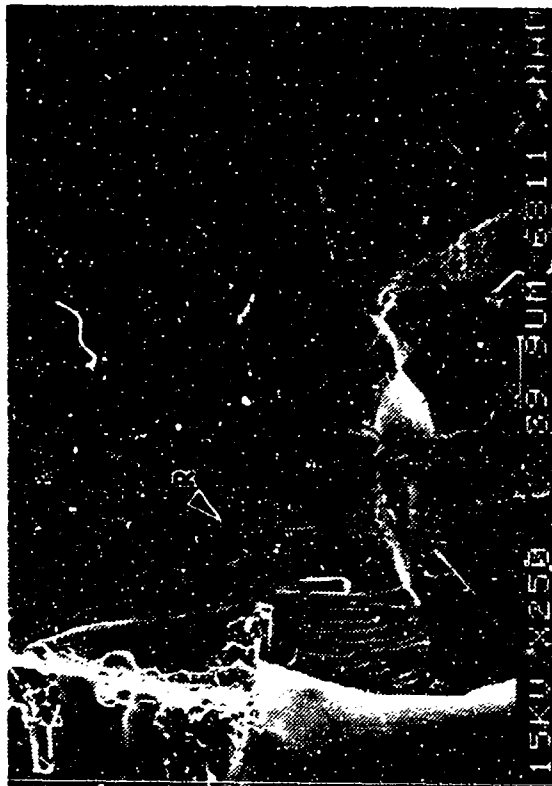
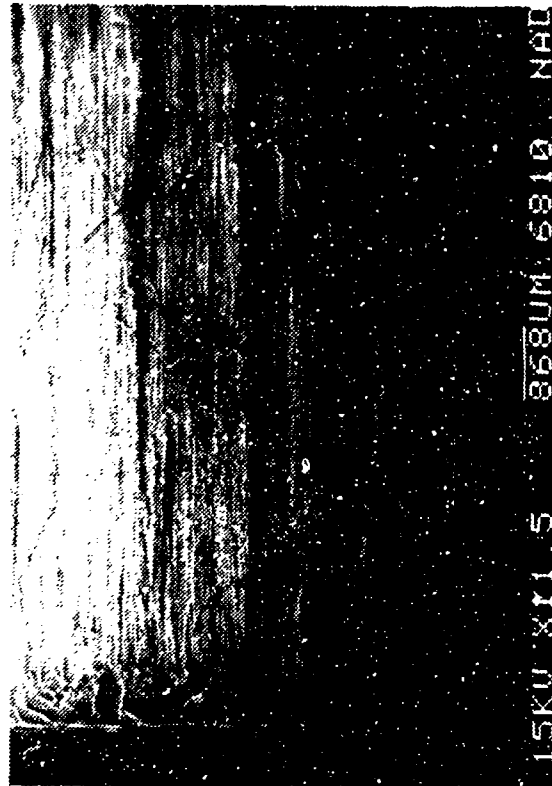
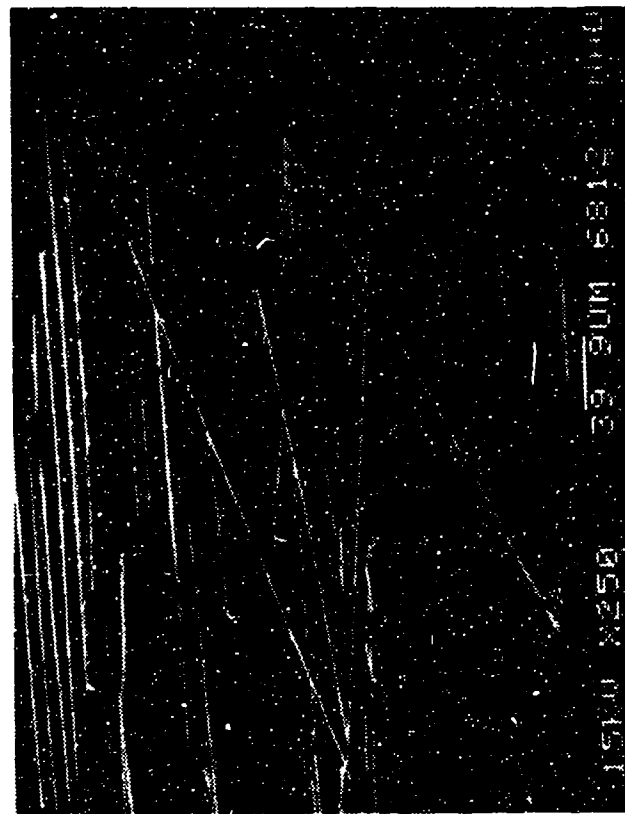
Figure 6-1. Optical and SEM Photographs of Mode I DCB Interlaminar Tension Fracture in AS4/5250-3 Gr/BMI - [0]_{24T}, Room Temperature Ambient
(a) Macro photograph of Fracture
R = River patterns
CD = Crack-propagation direction

Figure 6-1. (Continued)
 (d) Clean Fibers in Crack-Growth Region
 (e) Stray River Patterns (R) Oriented at an Angle to CD
 CD = Crack-propagation direction

Figures 6-1 through 6-4 provide interlaminar fractographs and Figures 6-5, 6-6 and 6-7 provide translaminar fractographs. This contribution was made by Northrop.

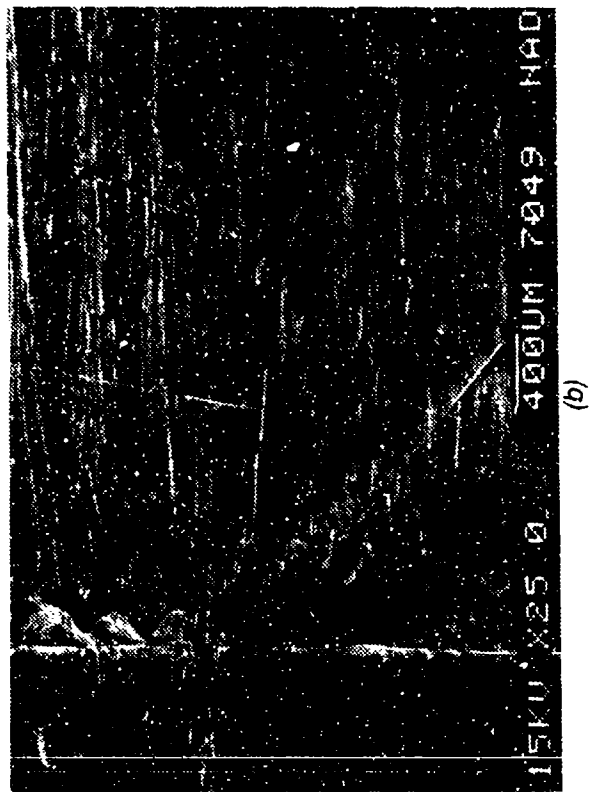
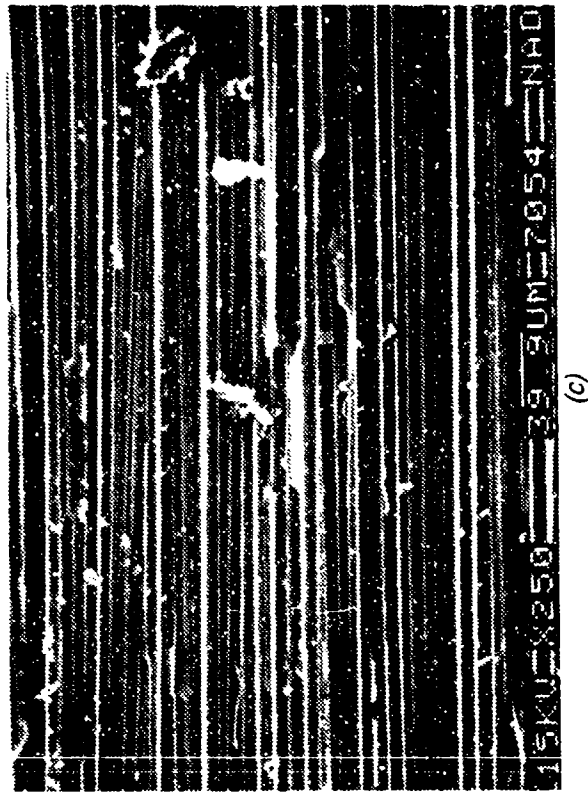
Figure 6-2. Optical and SEM Photographs of Mode I DCB Interlaminar Tension Fracture in AS4/5250-3 Gr/BMI - [0]_{24T}, Water Immersed Before Test
 (a) Macrofracture of Fracture
 (b) Precrack Region
 (c) Crack-Growth Region
 CD = Crack-propagation direction

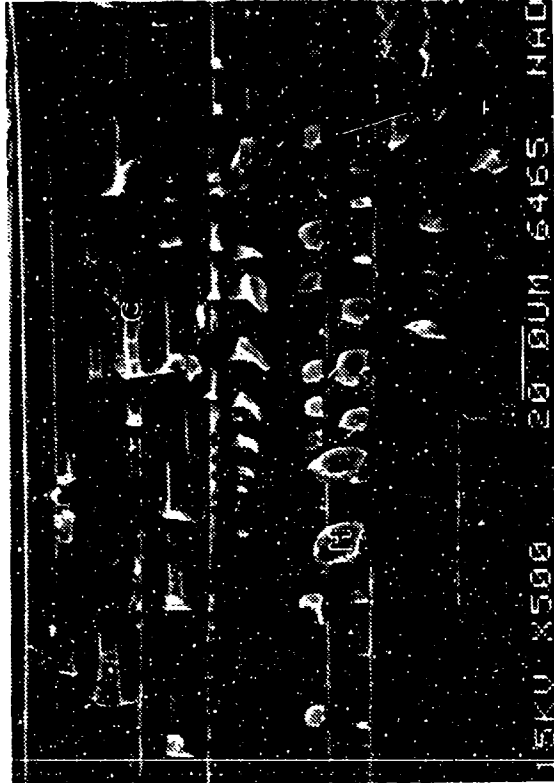
Figure 6-3. Optical and SEM Photographs of Mode II ENF Interlaminar Shear Fracture in AS4/5250-3 Gr/BMI - [0]_{24T}, Room Temperature Ambient

- (a) Macro photograph Showing Regions I, II, and III (Pre-crack, Crack-Growth, and Laboratory Overload)
- (b) River Patterns (R) in Initiation Region in Pre-crack
- (c) Hackles (H) and Cusps (C) in Crack-Growth Region
